**CORROSION RELATED FAILURES IN THE
PULP AND PAPER INDUSTRY**

Project 3309

**Report One
A Progress Report
to**

November 15, 1976

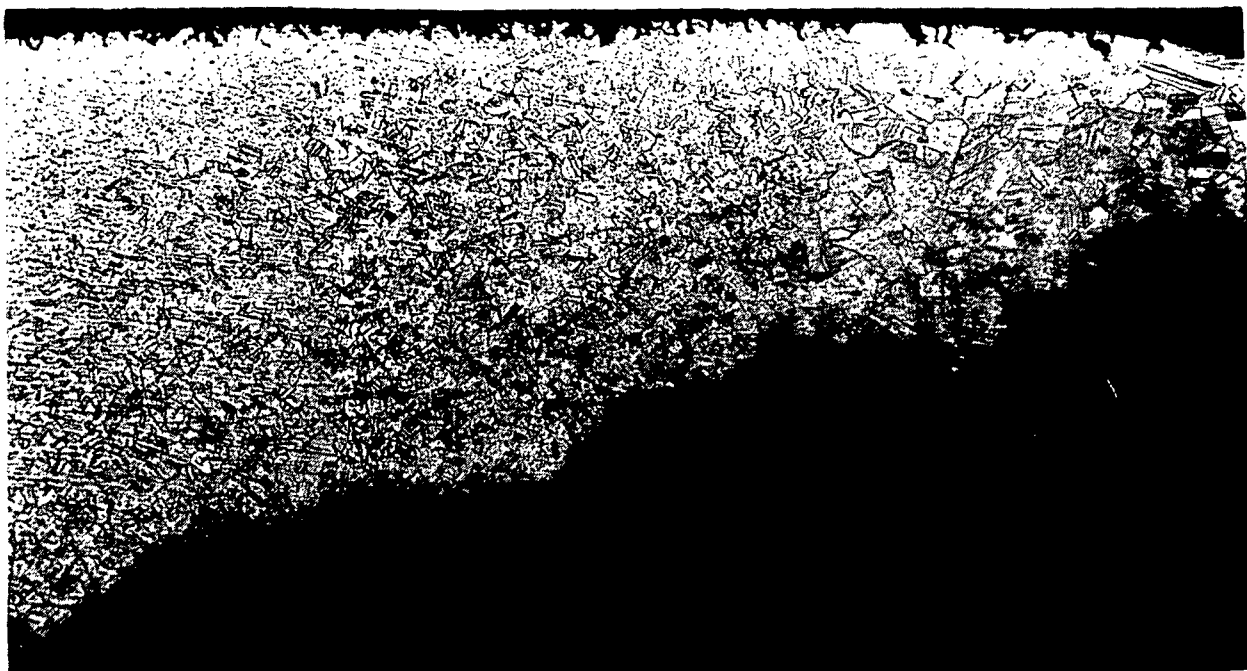
Metallographic samples were taken from Location 1 to analyze the morphology of pitting and stress corrosion cracking and the grain structure in weld, parent metal, and heat affected metal zones. Figure 12 shows transgranular stress corrosion cracking at all pit locations while Fig. 13 shows the weld and heat affected zones (left) as a somewhat finer grain structure than that of the parent metal (right).

The pitting and transgranular stress corrosion cracking depicted in Fig. 12 is typical of chloride attack in its two most prevalent corrosion forms on Type 304 stainless steel (12). There was no evidence of carbide precipitation or intergranular attack in the weld or heat affected zone. In addition, Fig. 13 shows that pitting attack was less severe on the outside of the tube, being confined to shallow penetrations at the grain boundaries. The lack of carbide

Figure 13. Metallographic Cross Section Showing Weld at Left, Heat Affected Zone (Center Right) and Parent Metal (Coarser Grain Structure - Right) in Tube at Location 1 (Figure 8). The Top of the Photomicrograph Shows the Shallow Grain Boundary Pitting Attack at the Outside Tube Surface and the Bottom of This Section Shows the Deeper Attack on the Inside Tube Surface

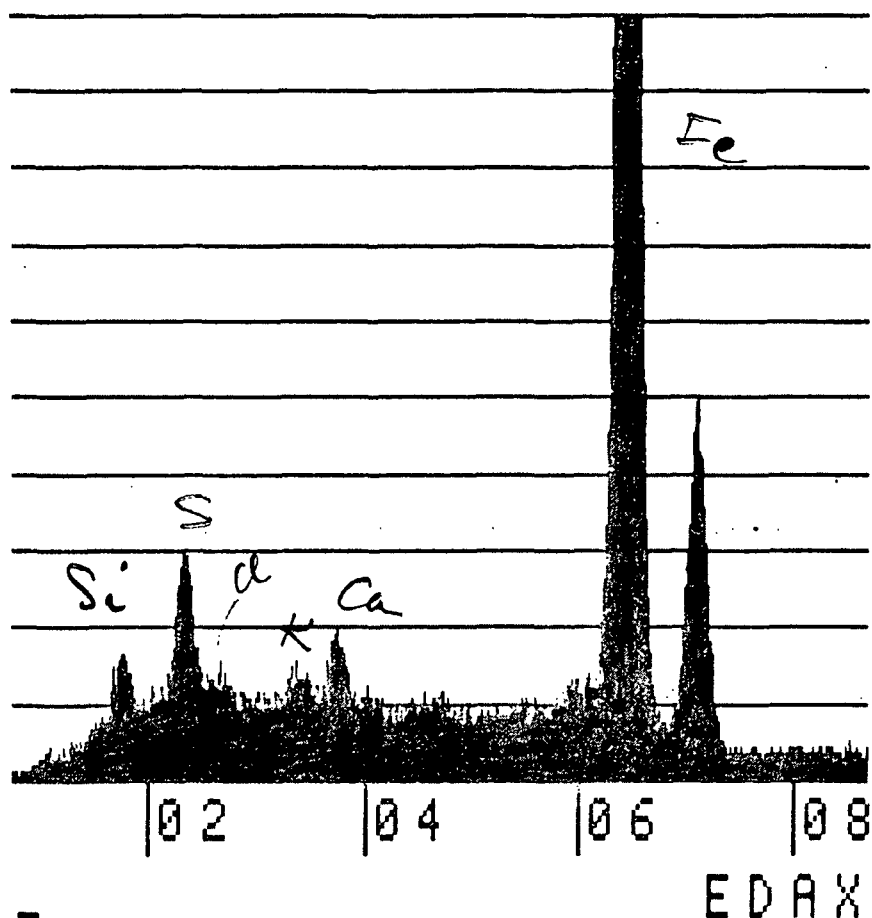
An x-ray diffraction analysis was run on a sample of the deposit scraped from the side of the tube. The results indicated that the major portion of the sample was amorphous.

Figure 16. X-ray Spectra of the Corrosion Products at the Location of SEM Photomicrographs (Figure 2)

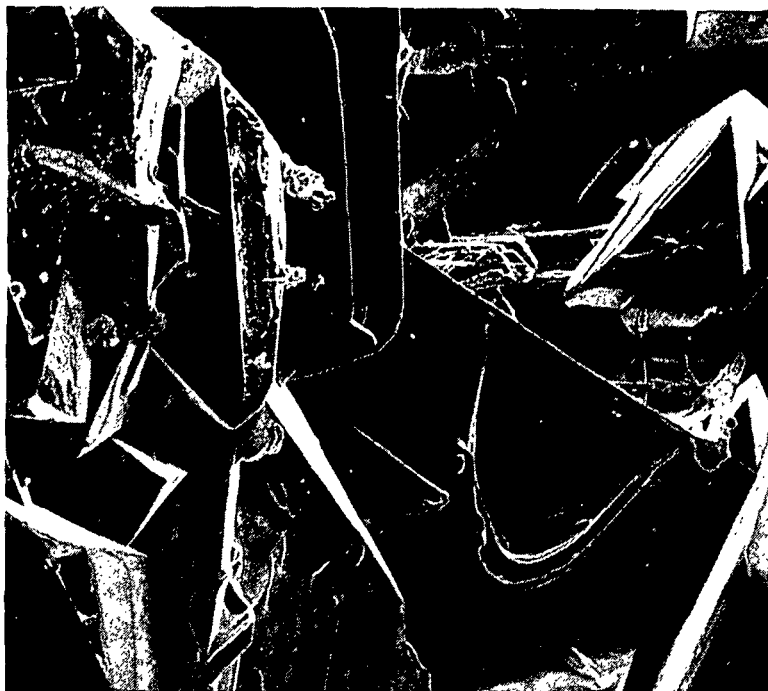
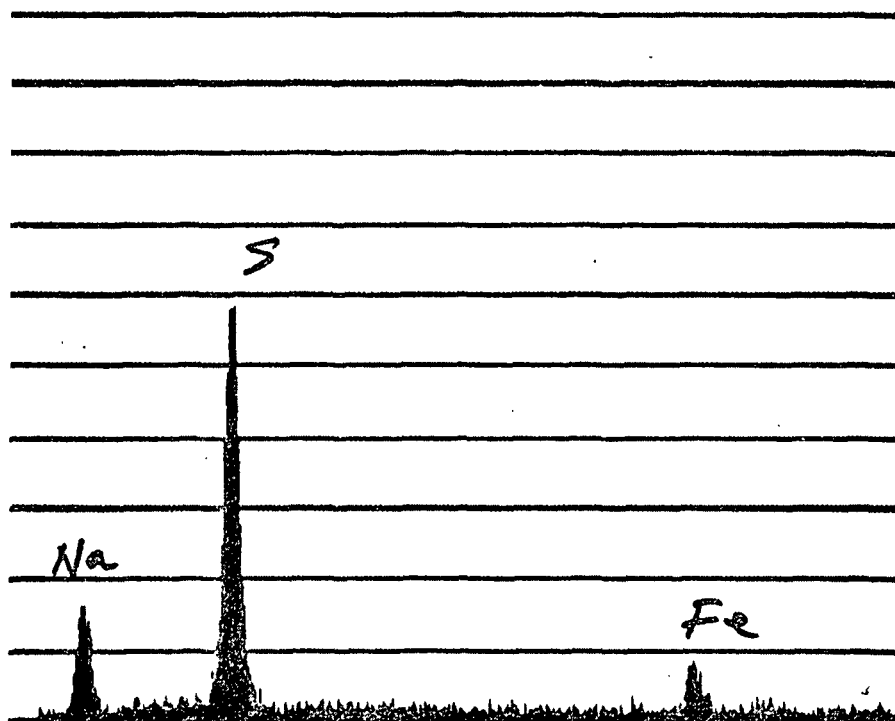
Figure 18. Structure and X-ray Spectra of Layer No. 1 (Saltcake Side)

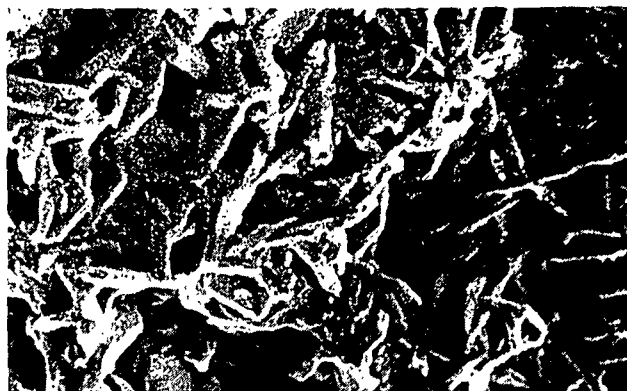
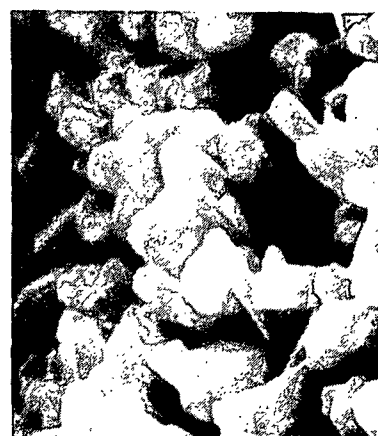
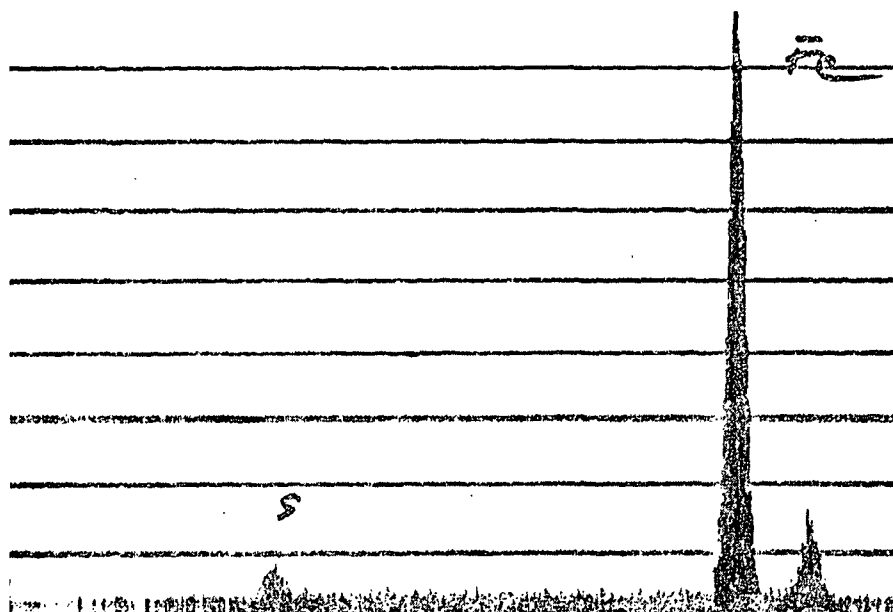
Figure 19. Composition and Structure of Layer No. 2 - First Layer Beneath Saltcake.
Analysis Indicates This Product to be $\alpha\text{Fe}_2\text{O}_3$

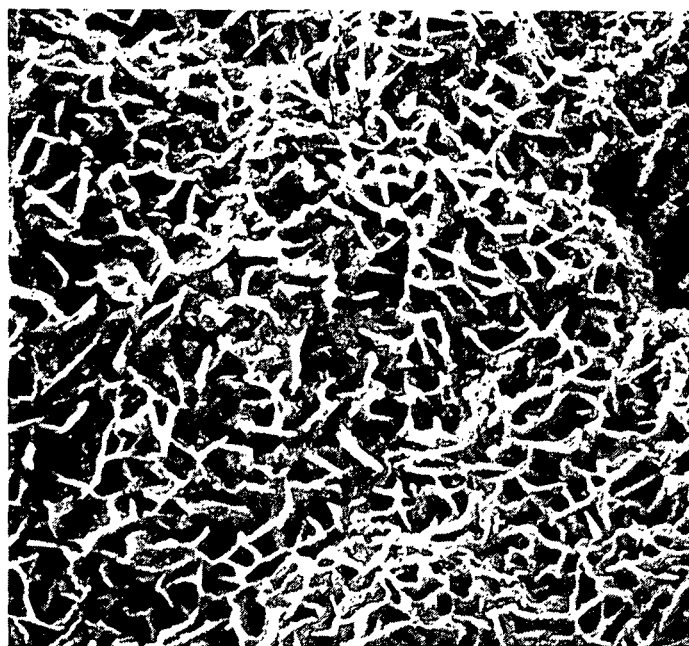
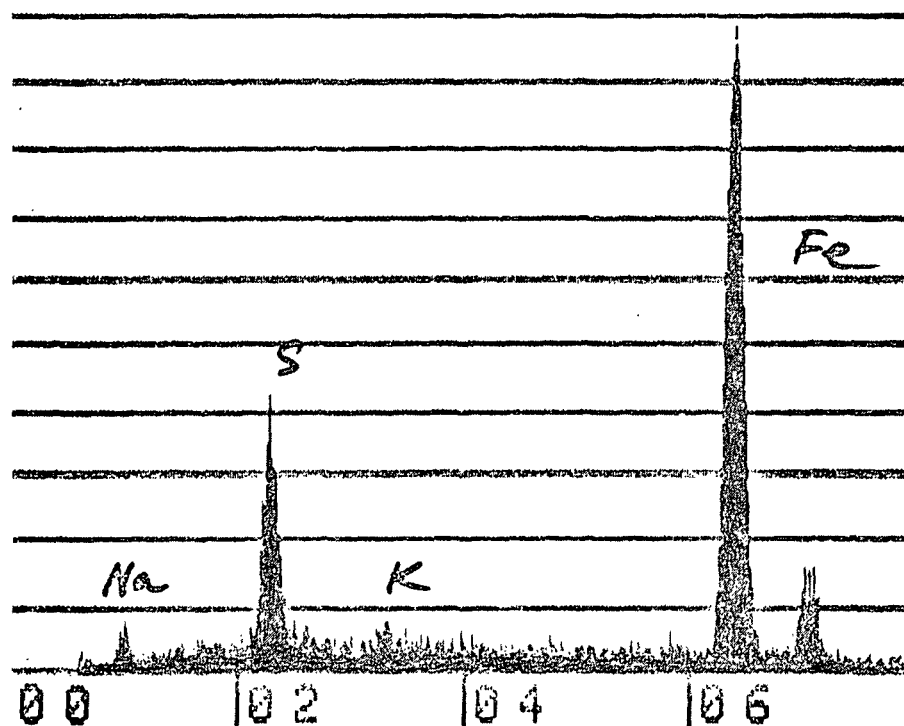
Figure 20. Composition and Structure of Layer No. 3

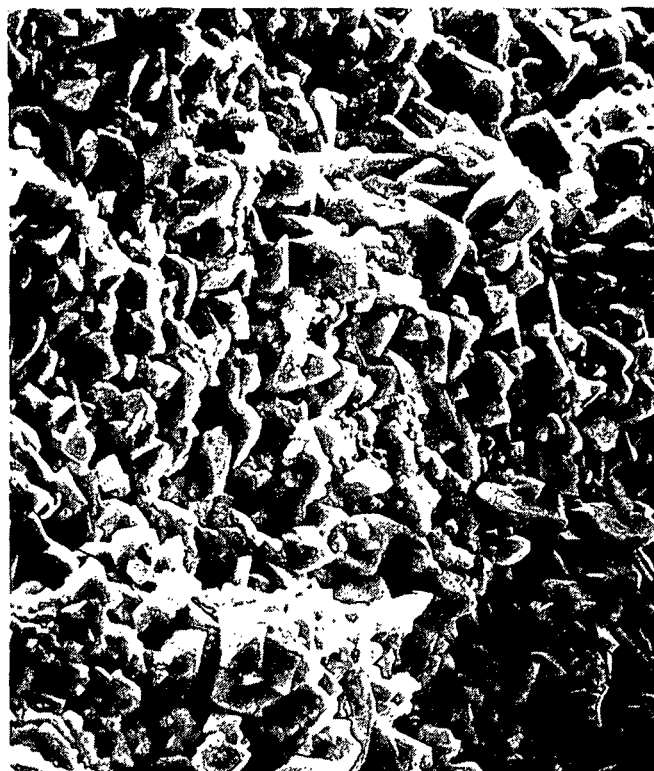
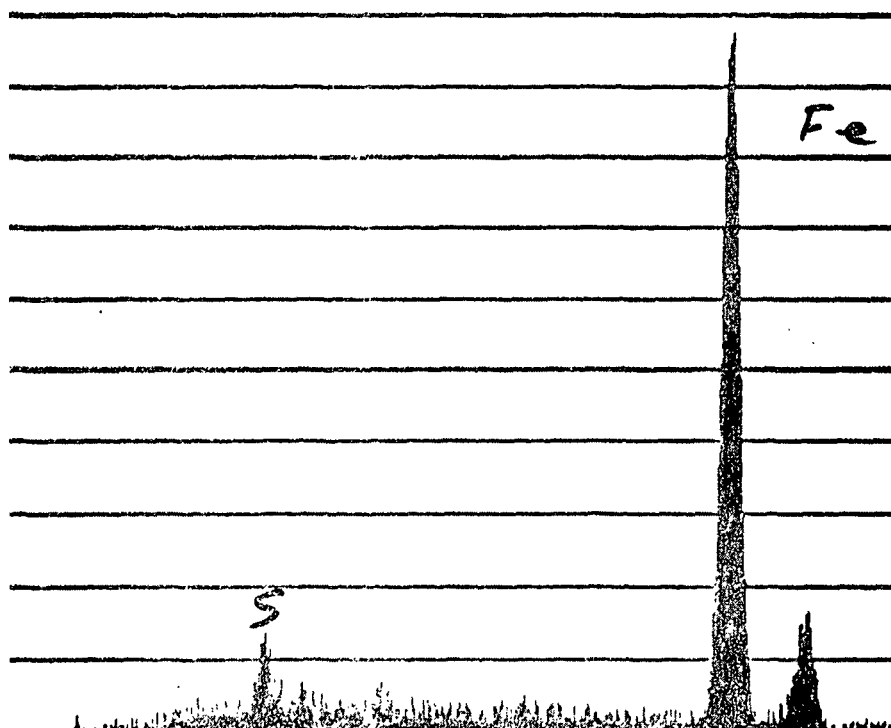
Figure 21. Composition and Structure of Layer No. 4 — Identified as Fe_3O_4

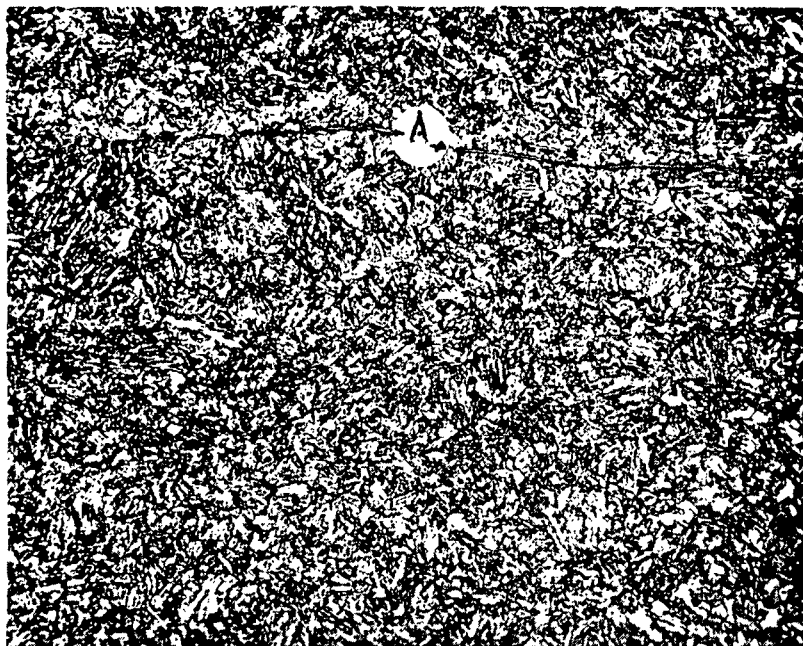
Figure 24. Photomicrograph Showing the Metallurgical Structure of the Bolt is That of Tempered Mortensite. Note Stringer Type Inclusions in Region Labeled A

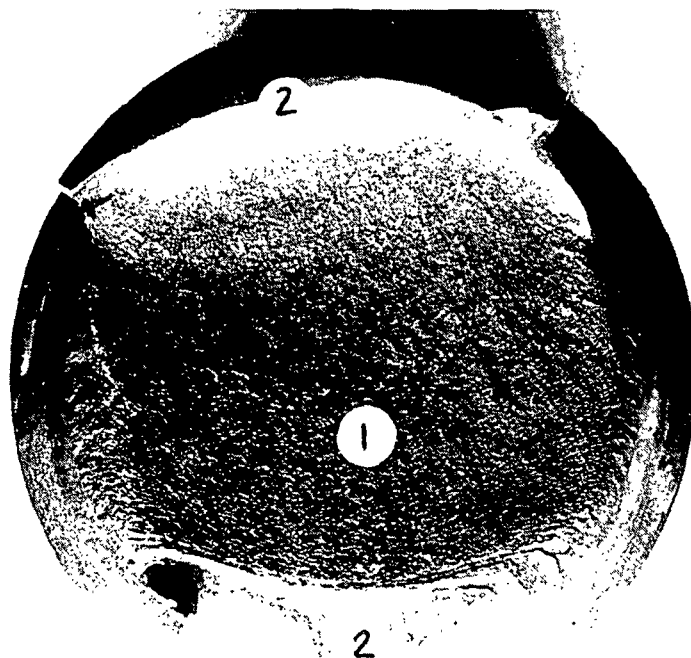
Figure 25 is a macrophotograph of the fracture surface. It shows that the major portion of the fracture was caused by fatigue. This region of fatigue fracture terminates in the two final fracture areas which appear as shear lips at the top and bottom portion of the bolt.

Figure 25. Macrograph Showing the Two Regions of Fracture Surface Morphology — The Fatigue Region Labeled 1 and the Last to Fail Ductile-Tensile Region Labeled 2

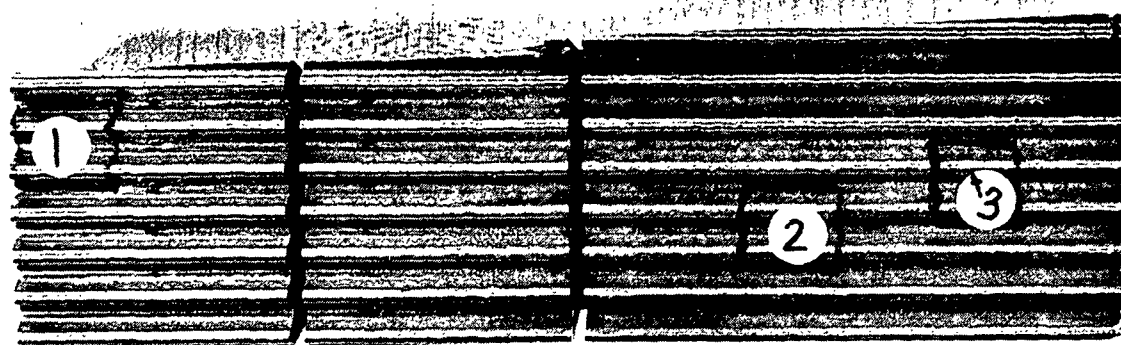
Figure 30 shows Section A removed - the end of the roll is on the left side of the photograph. Visual examination of this section at low power magnification disclosed evenly distributed and highly deformed "waviness" along the flute tips. The "waviness" was in the form of brinnelling or peening across the tip. Also, pitting corrosion of the base metal was evident in those areas free of

Figure 30. Photograph of the Section Cut from Location "A", Shown in Figure 13. Samples Marked 1, 2, and 3 were Removed for Further Analysis. Arrow on 3 Points to Speck of Chrome Plate

Smaller samples (labelled 1, 2, 3 in the photograph, Fig. 30) were cut from this section for microscopic and metallurgical analyses. Sample 1 is in the area outside the working width where there is better coverage of the chromium plating. Sample 2 is representative of the areas of greatest wear, lack of chrome plate and a pit located in the valley of the flute profile. The area of Sample 3 was selected because it contains a patch or speck of chrome plate on the flute tip (arrow points to it in Fig. 30) which was large enough to permit microscopic and metallographic analysis.

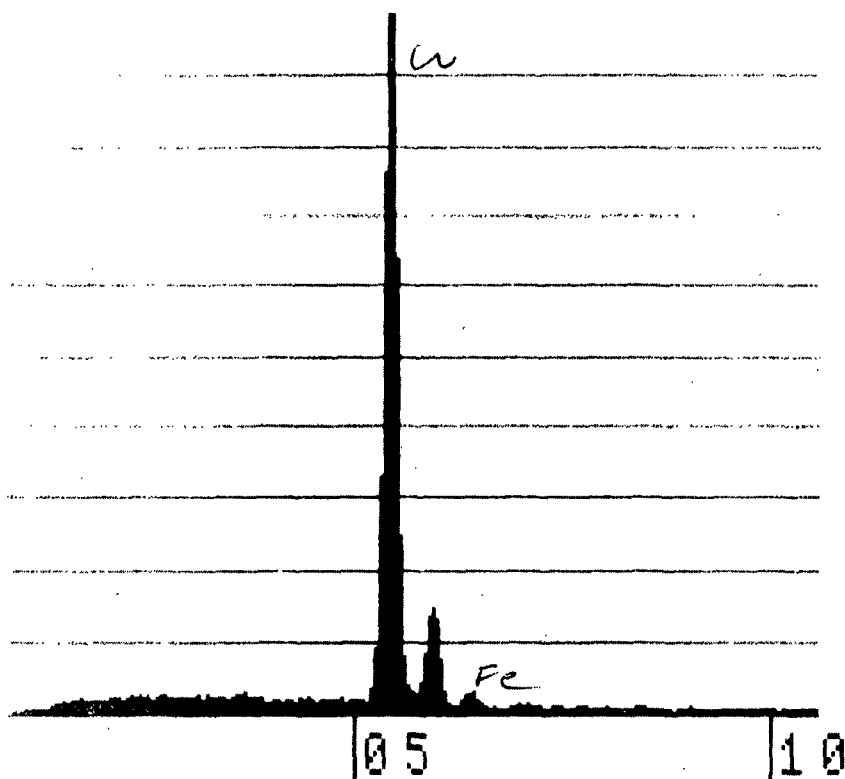
Since the tip of the flute in Sample 1 appeared to retain the best characterization of the original chrome plate, a closer examination was made of this surface. Both good and bad areas were detected, and x-ray analyses were made of each. Figure 32 shows that even in areas where chrome plate appeared good small amounts of iron could be detected, indicating local regions of breakdown in the chrome plate. In areas of greater surface damage, a number of cracks in the chrome plate could be seen around points where the plate was completely dislodged from the surface (see Fig. 33). The x-ray spectra in this region shows the high degree of breakdown (high iron peak) as well as the presence of silicon and calcium.

Figure 32. SEM Photograph and X-ray Spectra of a Local Region on the Flute Tip of Sample 1 Where Chrome Plate Coverage was Best. SEM at 200X

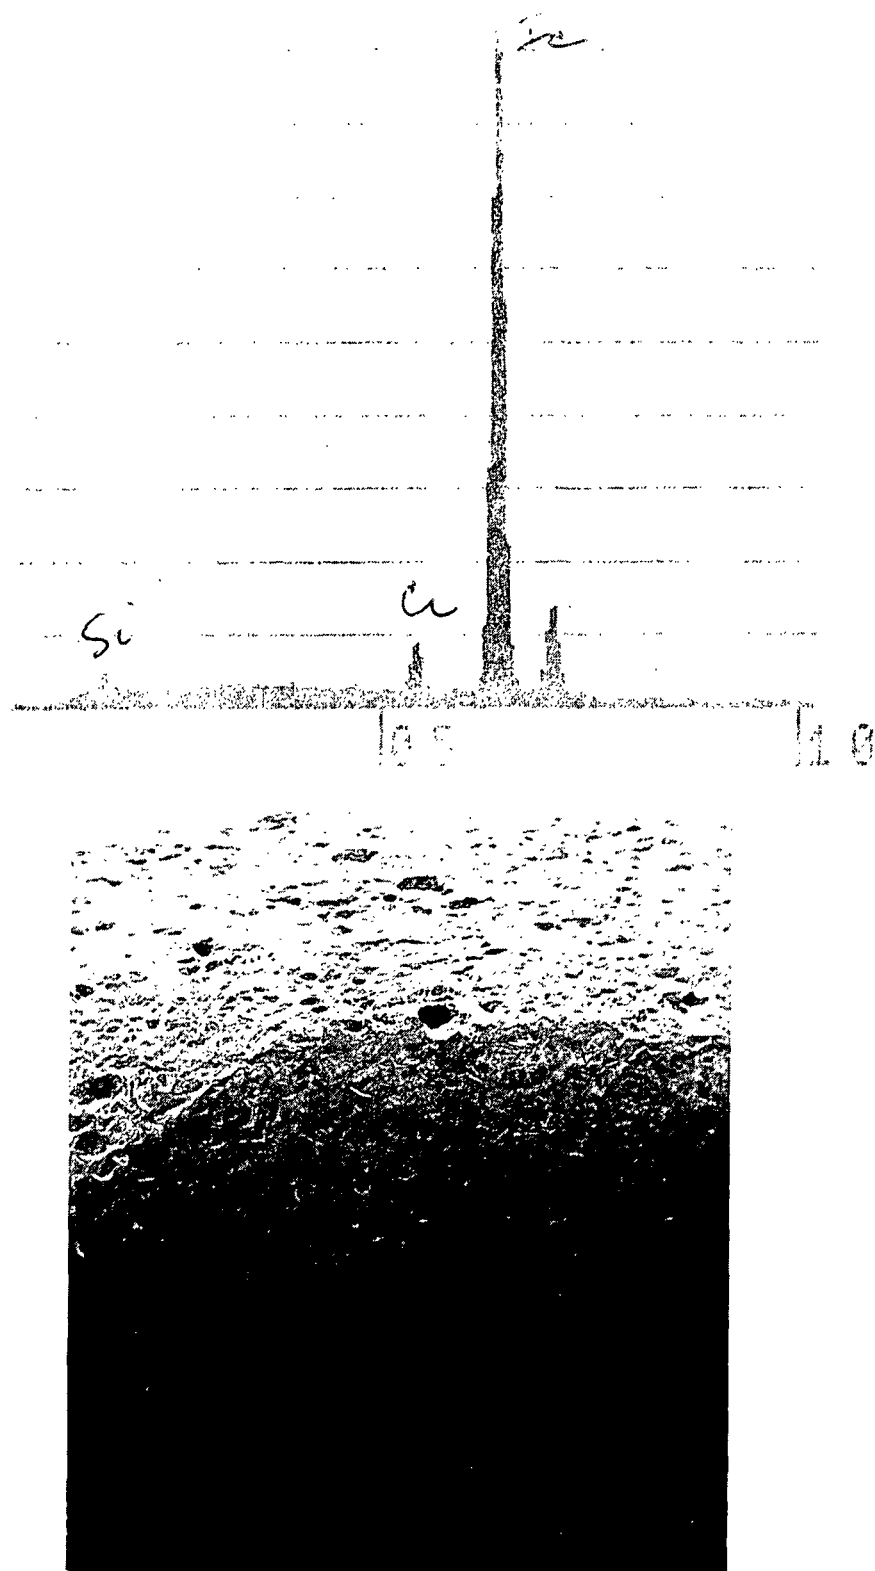
The same type of severe deformation and surface disruption on flute tip and valley was found on Sample 3. Figure 37 shows the perforated crater pattern that exists in these areas. In addition, x-ray spectra of these regions in the flute tip area confirms the presence of the same elements found in the valley, namely, high iron peak (base metal exposure), silicon and calcium (Fig. 36).

Figure 37. SEM Photograph (40X) and X-ray Spectra of the Flute Tip
in Sample 3

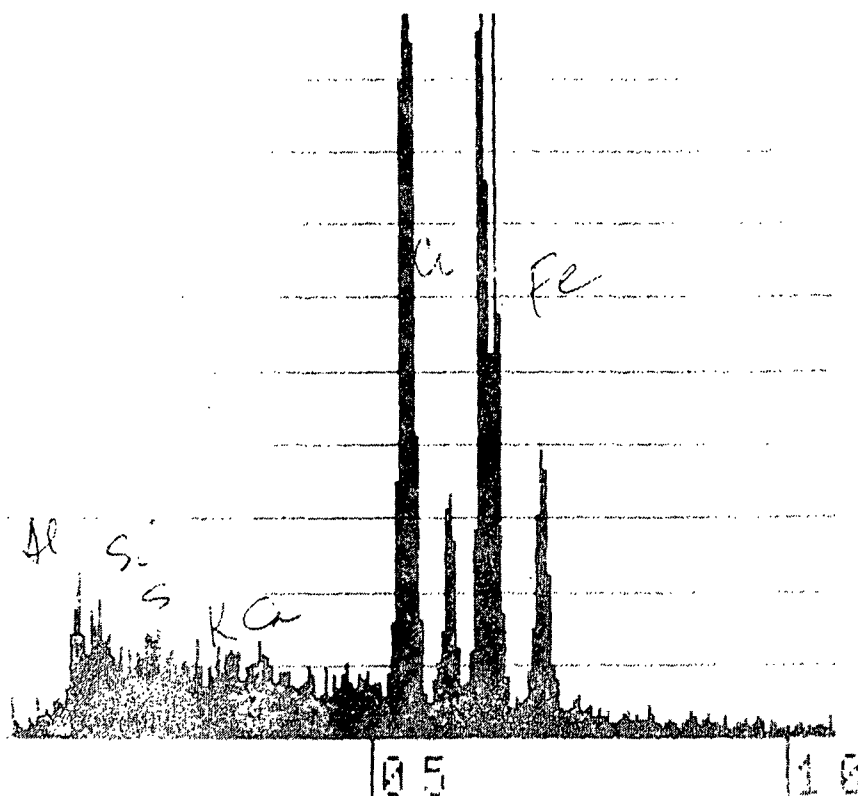
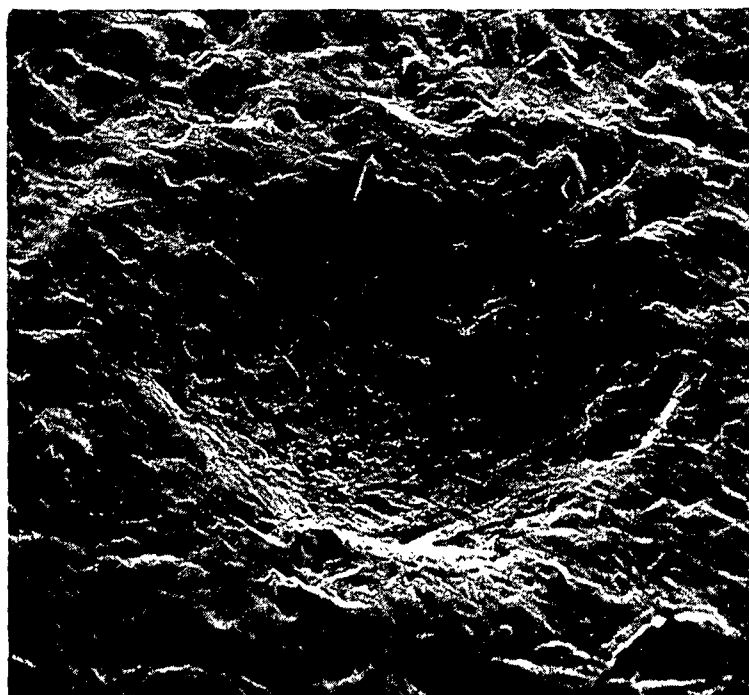
Although the surface damage along the side of the flute was less severe than valley or tip, the craterlike appearance of the surface prevailed. Figures 38 and 39 are photographs of typical regions in these areas. In addition to the elements found previously, aluminum and potassium were also present in these areas.

Figure 38. SEM Photograph (200X) and X-ray Spectra of a Local Region Typical to That Found Along the Side of the Flute in Sample 3

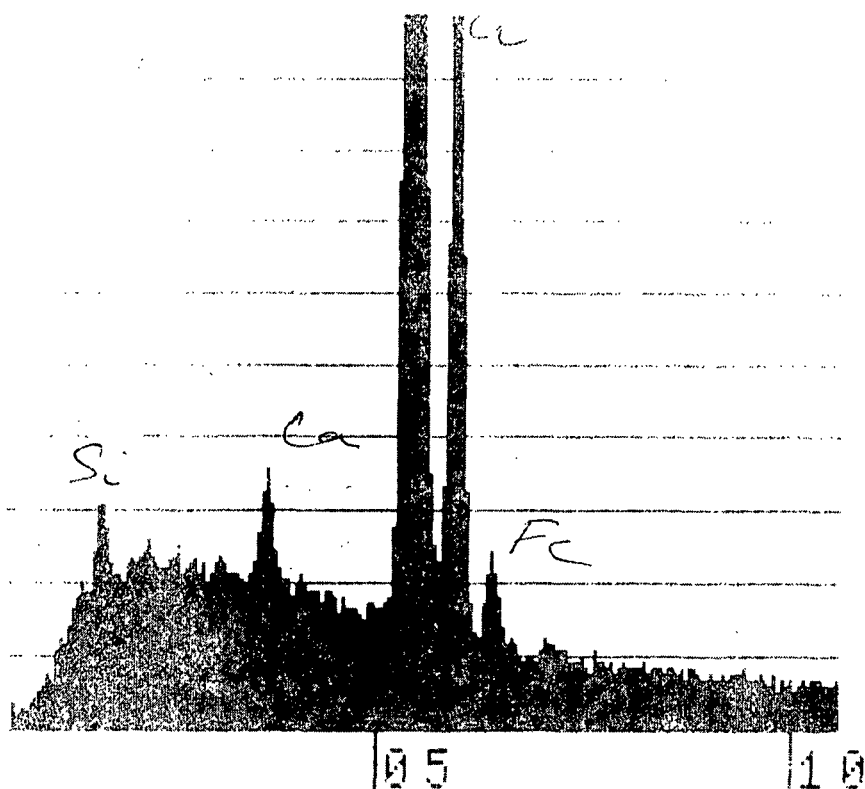
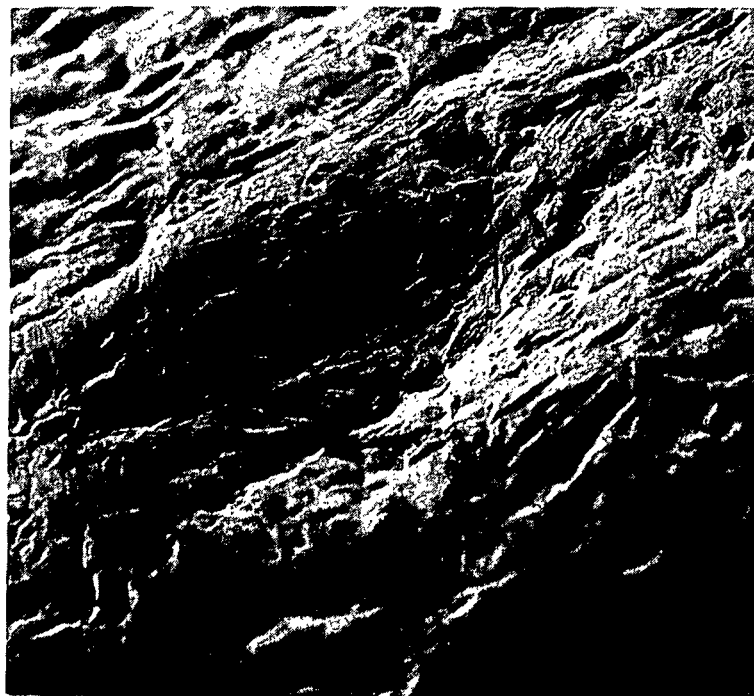
Figure 39. Same as Figure 19, Taken in a Different Area Along the Side of the Flute. Magnification 300X

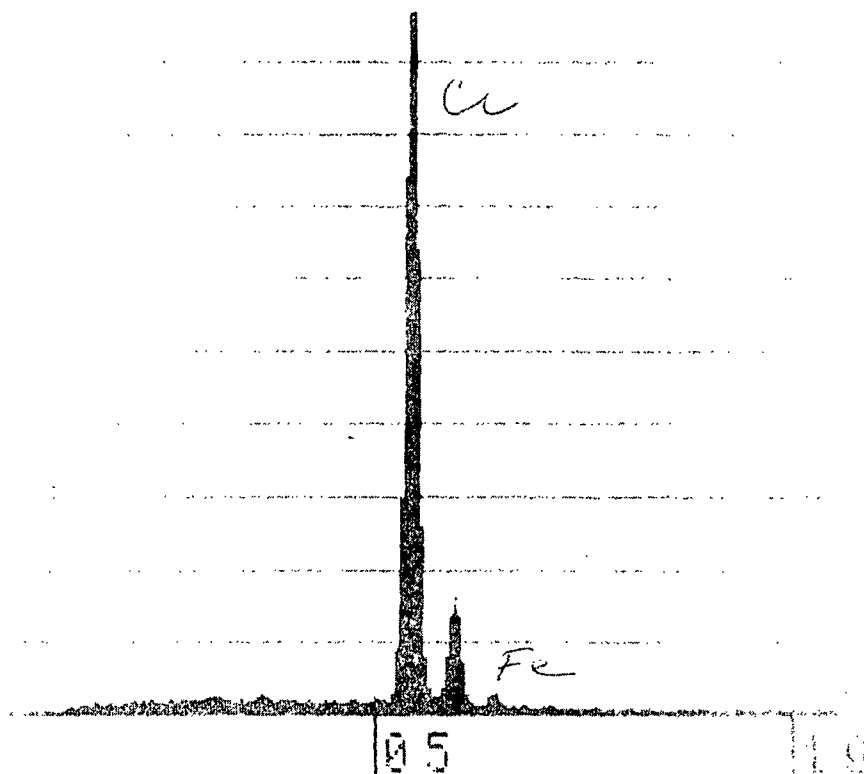
There was an area of chrome plate on Sample 3 noted visually (see Fig. 30). This was confirmed by the x-ray spectra (Fig. 40) and the sample was sectioned in this area for metallurgical analysis.

Figure 40. X-ray Spectra of Area Where Some Chrome Plate Remained on the Tip of the Flute Within the Working Width of the Roll
